Monitoring Data Record

Project Title: R-2248BB – Charlotte Outer Loop COE Action ID: 200131321
 Stream Name: UT Thomas Pond (Site 9) DWQ Number: 011231
 City, County and other Location Information: Mecklenburg County, Charlotte Outer Loop, NC 27 Exit (Mount Holly Road)
 Date Construction Completed: April 2005 Monitoring Year: (3) of 5
 Ecoregion: _____ 8 digit HUC unit 03050101
 USGS Quad Name and Coordinates: _____

UT Thomas Pond

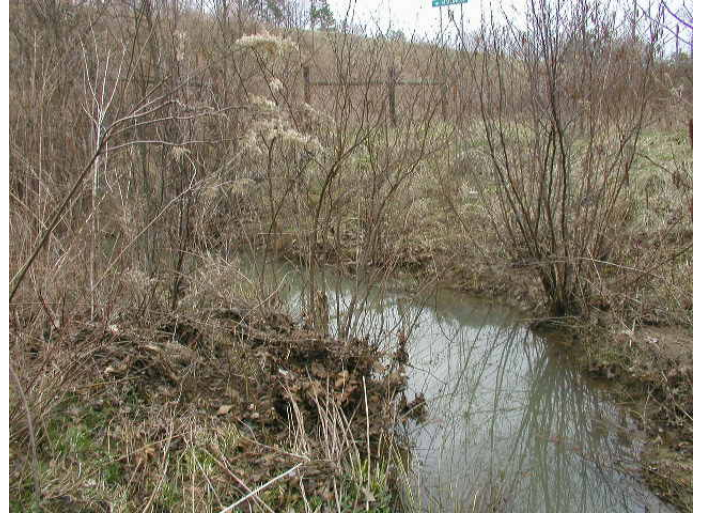
UT Thomas Pond stream relocation is experiencing some instability for the Year 3 Winter evaluation. The crossvane at Sta. 217+80 -L- Photo Point #1 (Upstream) has water piping under the crossvane. A slight headcut is still located at Sta 219+00 -L- which is downstream of Photo Point #3 with no change. Another slight headcut which was noted last time at Sta. 1+00 Loop E, is still located between Photo Point #4 and #5 with no change. There were no grade control structures installed within the sections of stream where these headcuts have formed. These minor headcuts are not affecting the overall stability of the stream. There is evidence that a bankfull event has occurred since the last monitoring evaluation which has caused a divided channel to form. NCDOT will continue to monitor this stream relocation for channel stability and to see if any remedial action is warranted.
